BIOLOGICAL RESOURCES AND WETLAND SURVEY LETTER REPORT

Project Name: Rabbit Run Tentative Map - TM 5478

ER 06-08-017

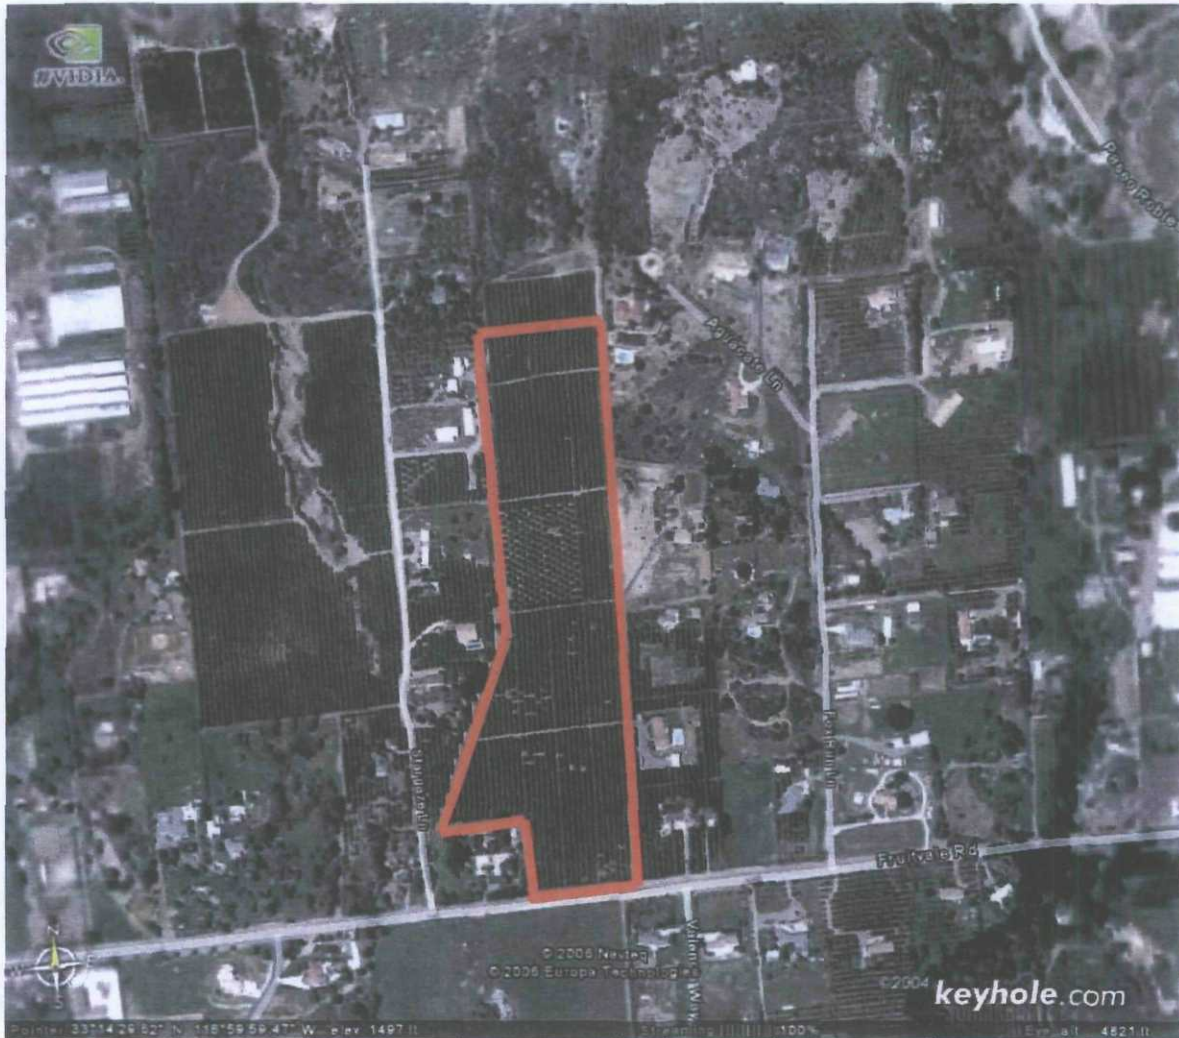
Figure 5. Color aerial photograph showing the project site. The project boundaries are shown in red.

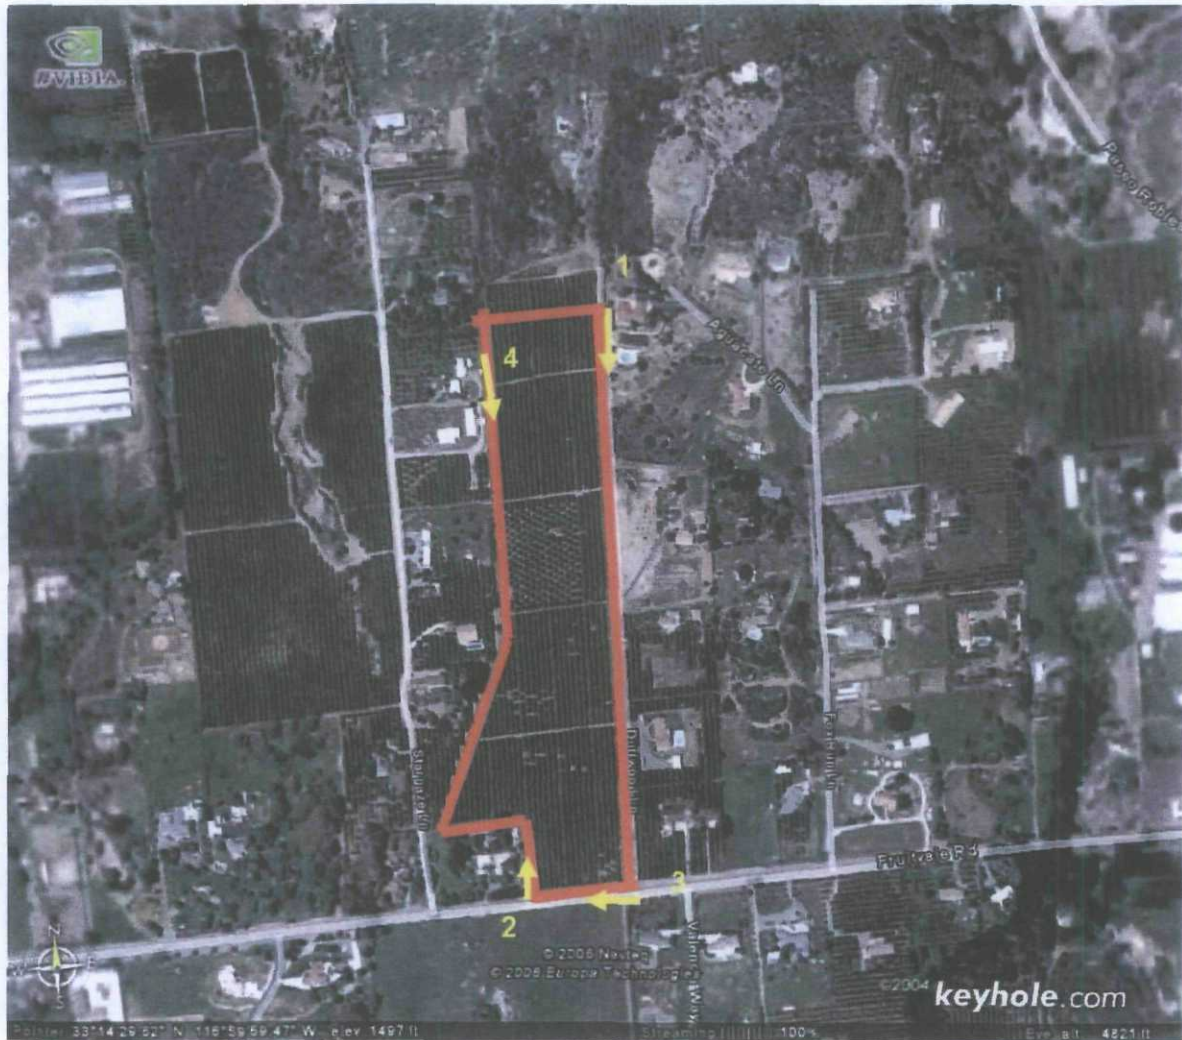
PHOTOGRAPH INDEX

Yellow arrows and numbers indicate the locations and directions from which the following photographs were taken.

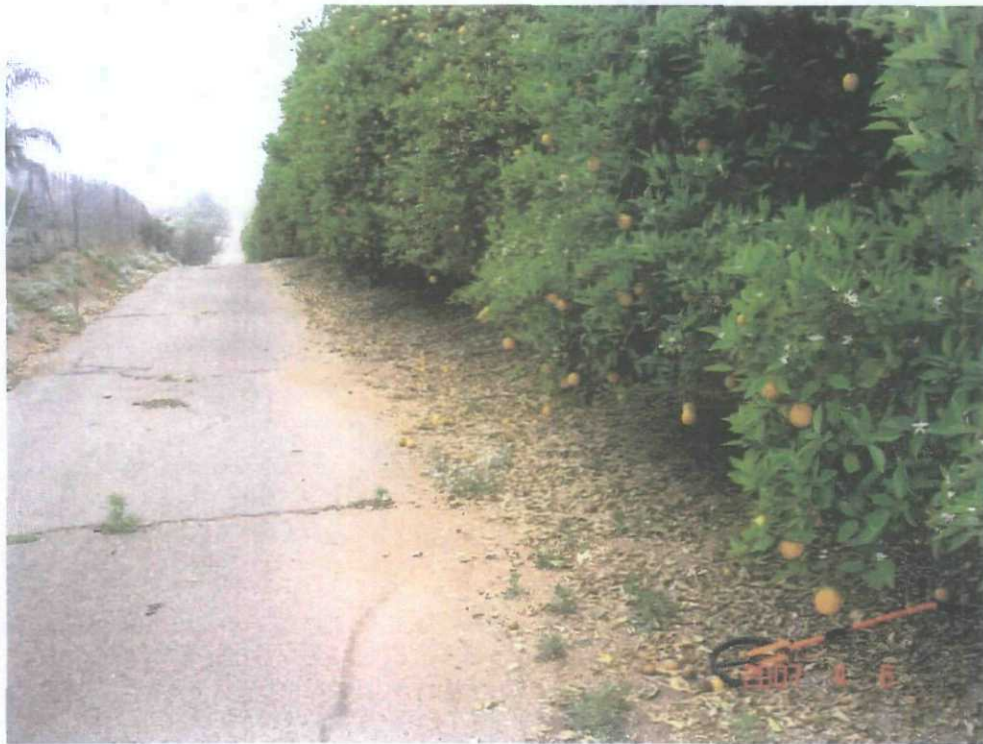
Photograph 1. View from the northeast corner of the project site looking south.

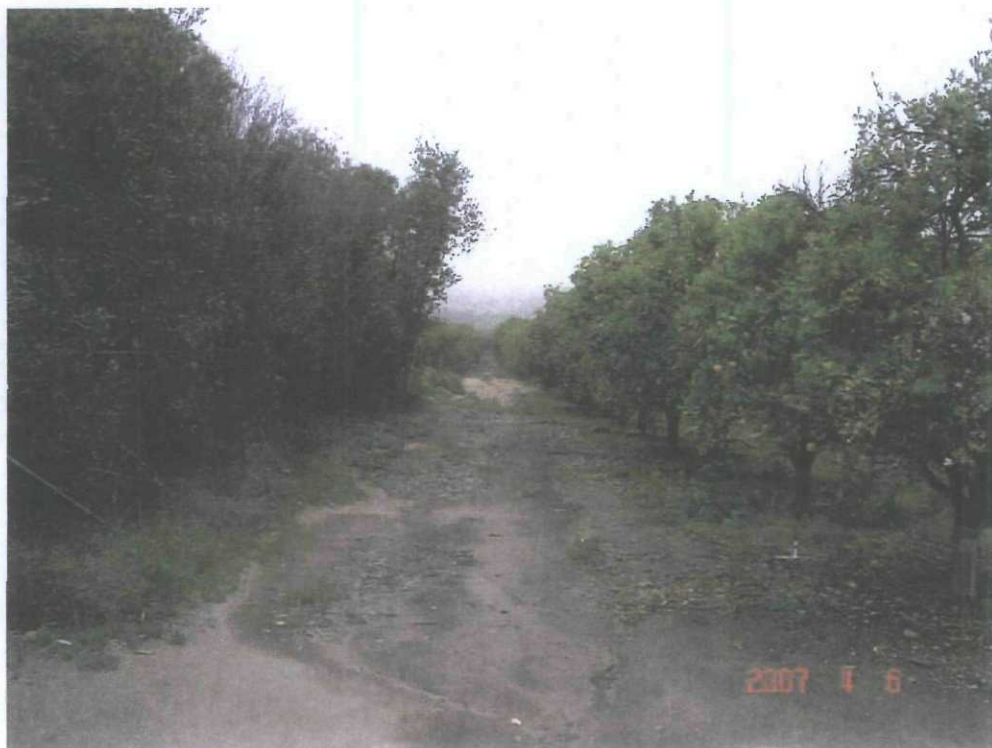
Photograph 2. View from the southwest corner of the project site looking north. An existing single family dwelling is off-site on the left.

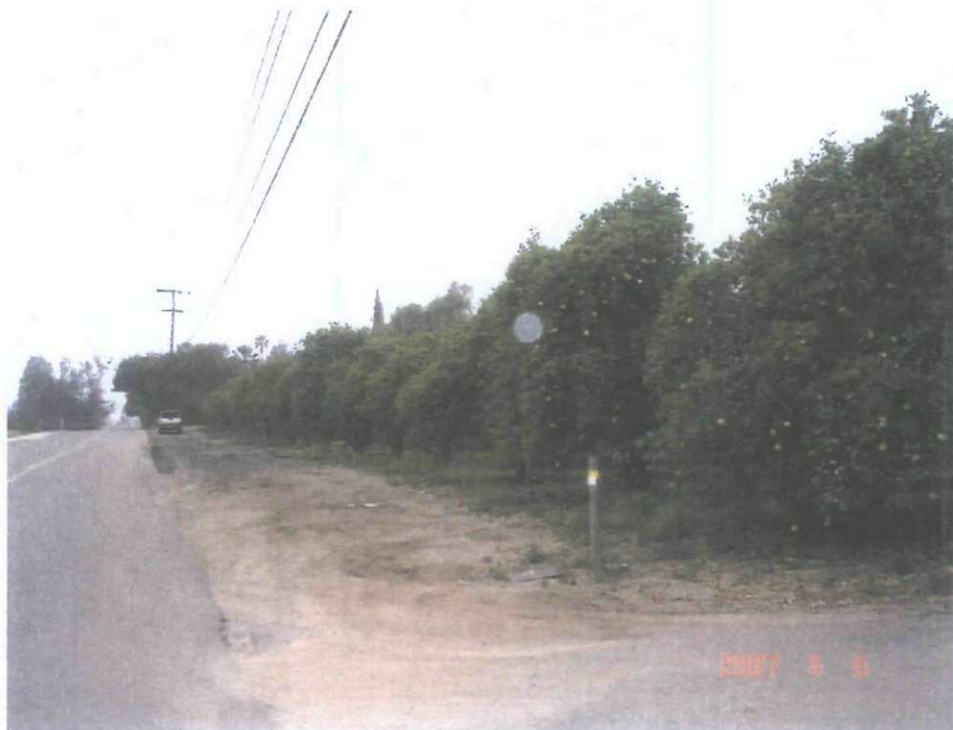
Photograph 3. View looking west from the southeast corner of the project site. Fruitvale Road is on the left and Duffwood Lane is in the foreground.

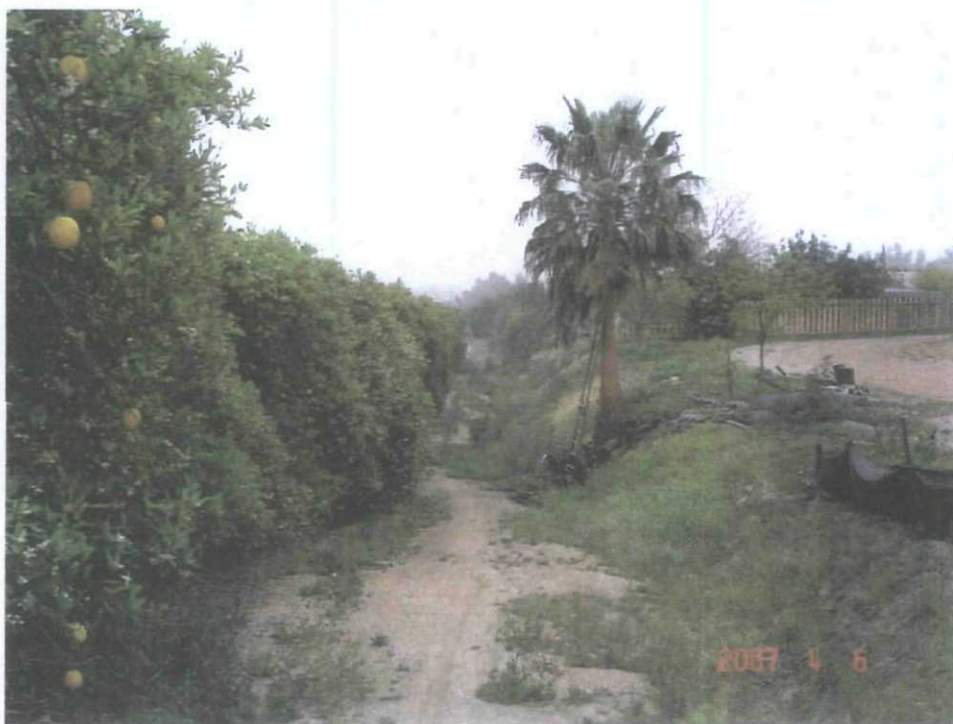
Along the west boundary of the grove portion of the site is a very narrow, incised artificial drainage diversion ditch (Photograph 4). This ditch is channeled along the west boundary of the project site, ultimately being routed through adjacent parcels. This drainage ditch was surveyed for wetland indicators (see Wetland Survey, below). This ditch has no wetland vegetation or other indicators that it is an RPO wetland, a U.S. Army Corps of Engineers wetland, a Waters of the United States, or California Department of Fish and Game wetland.

Photograph 4. View of the artificial drainage diversion ditch that borders the western property boundary.

No County of San Diego or other jurisdictional wetland was identified during the survey of the project site. This includes the narrow incised drainage diversion ditch that traverses portions of the project site along its western boundary.
